## Skyview Communication Trouble Shooting

Follow the below troubleshooting steps when you are unable to communicate with your Skystream turbine. These procedures should be used when the turbine is still operating, yet there is no communication. If you turbine does not spin and you have no communication, contact your dealer or Southwest Windpower.

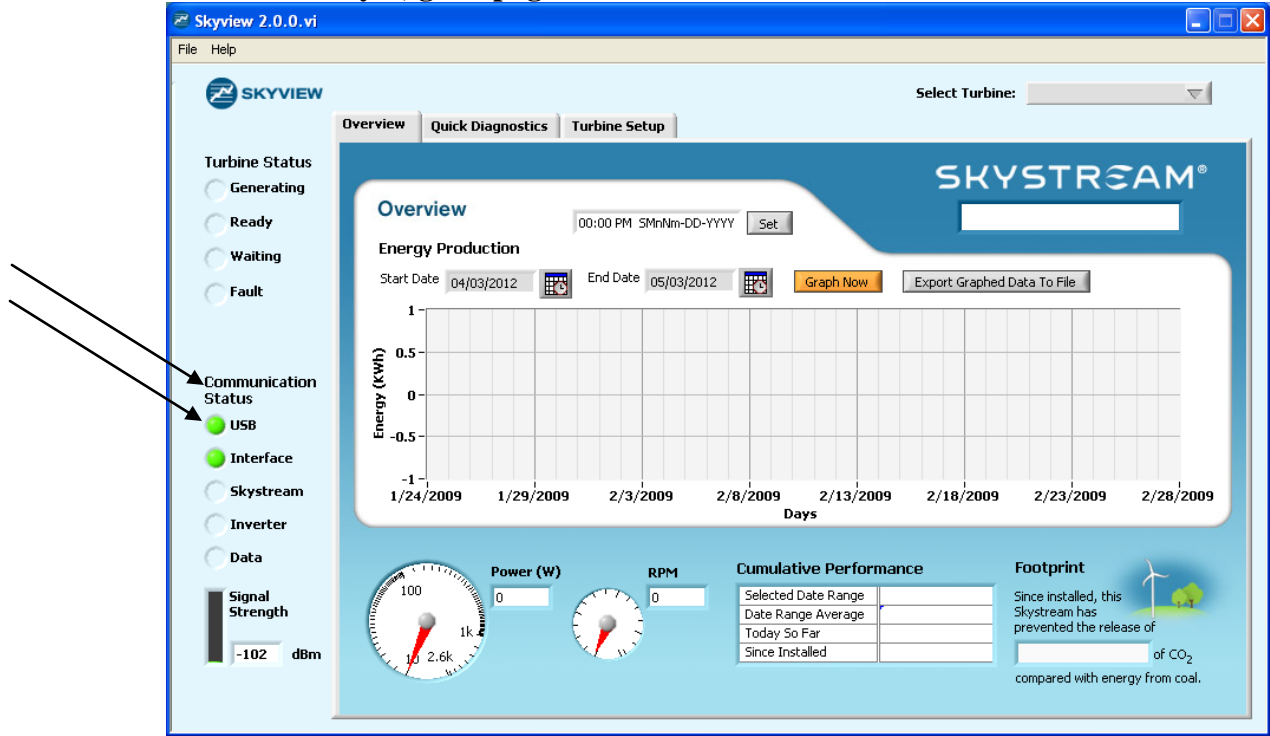
❖ **Communications Problem Type 1: Only the USB and Interface LED's illuminate? If yes, go to page 3.**

- **Communications Problem Type 1: If only the USB and Interface lights illuminate follow the below steps until communication is established:**
1. Confirm the antenna is still attached on top of the Skystream.

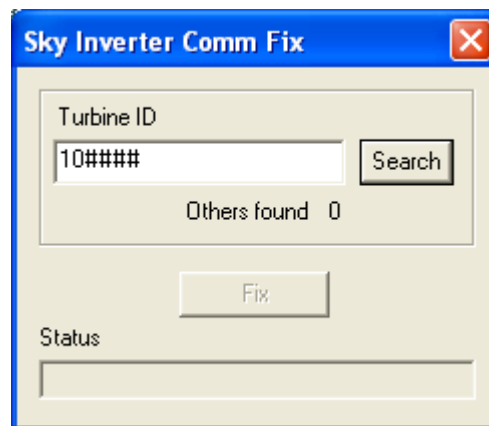
3. Enter the last six digits of the serial number in the *Turbine ID* field, no dash, and select *Search*. Note: You may have to select *Search* several times before this works!

4. When zserfix.exe finds the turbine the *Turbine ID* field will change from 10##### to SKY37A\_1010##### (or SKY37A\_2010#####)
